MFG: MANCO PRODUCTS, INC.  
NAME: ROUND UP - FOLD  
TYPE: NON-KIDDIE

**EMERGENCY ALERT ON THE RIDE, "ROUND-UP"  
(by Manco, Hrubutz Mfg, or Kilinski Mfg)**

In early June 1993, a Round-Up ride experienced a failure of a weld located on the shrink collar on the main center spindle (two drawings are attached for reference). This is the first known occasion for this style of shaft to fail since the manufacturer's Bulletin requiring replacement of an earlier system.

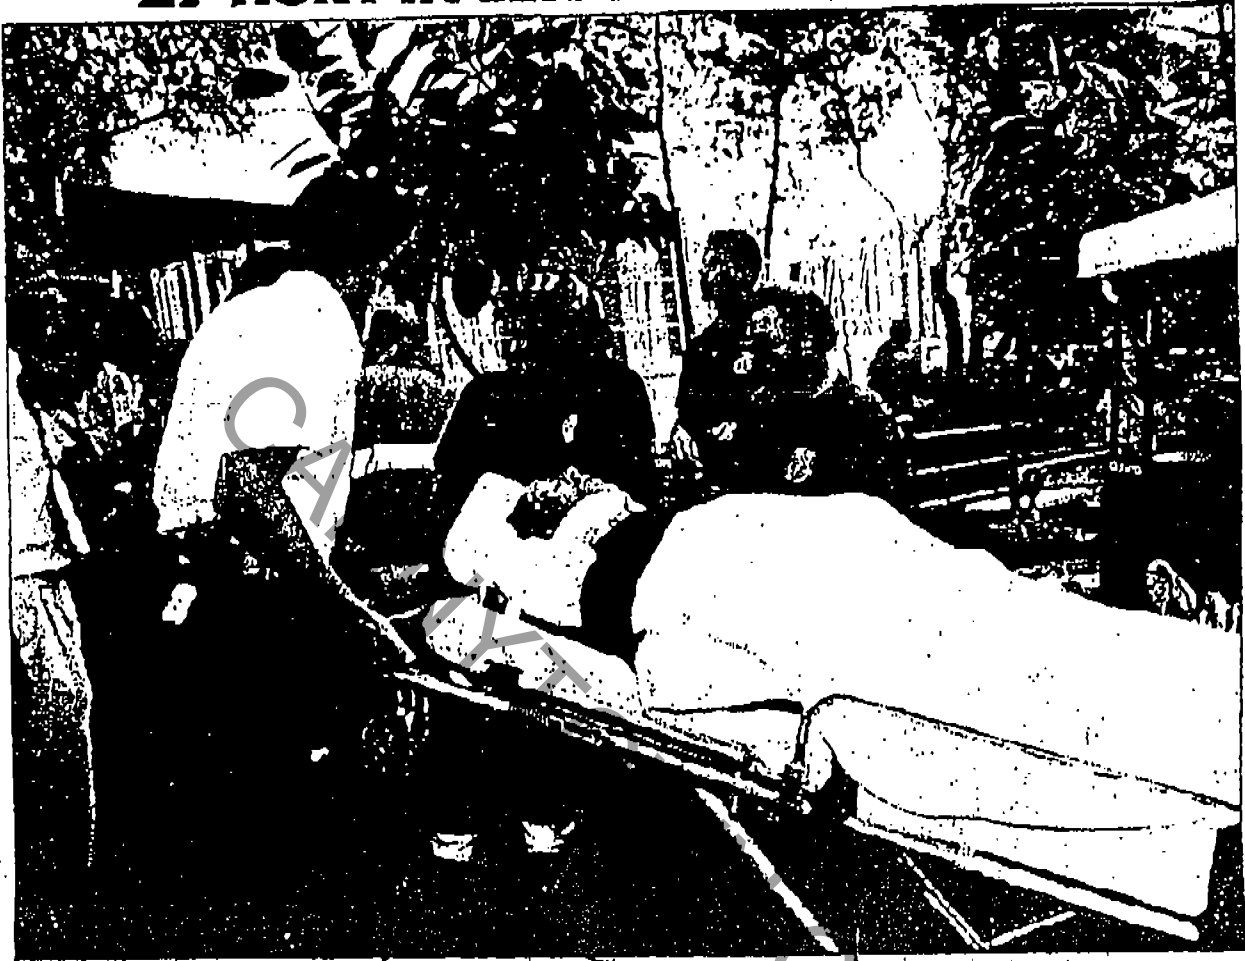
An injured man is wheeled off after an accident on the Round-up ride at Elitch Gardens.

Denver firefighters were dispatched at 7:43 p.m. to rescue 30 stranded passengers on the Round-up ride after one of 16 horizontal metal struts came loose, park officials said. The spinning, tilting ride stopped abruptly.

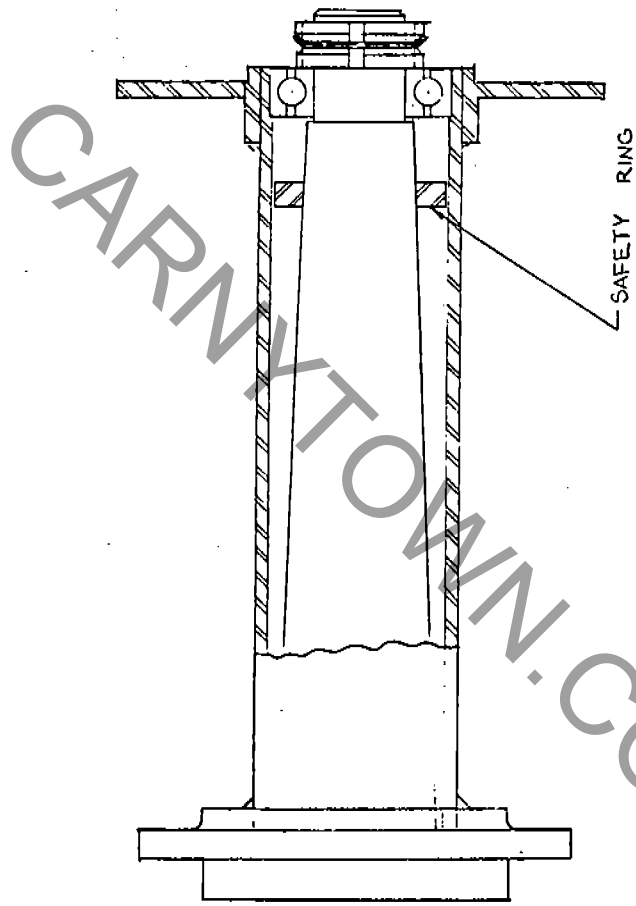
MAN-CO MFG. INC. 100 PLYMOUTH ST. BURLINGTON, MASS.	
SAFETY RING	INSTALLATION
DATE 2-17-72	
DRAWN BY S.M.E.	
SCALE	NO. PD-35-R

A Round-Up manufactured by Frank Hrubetz & Co., Inc. has experienced a failure in the upper bearing in place on the main spindle. When this happened, support at the top of the spindle was lost making it possible for the rotating platform to tilt and contact the main boom.

1. Remove the center ornament and inspect the weld on the hub (shown in drawings RD-35R and FR-503S) for cracks. If there are cracks, ship the hub to Man-Co Mfg.. We will repair, using the design presently being used.
2. Remove the top bearing and visually inspect the bearing and make sure there is a safety limiting ring in place. If there is a limiting ring on your ride, it will be plainly visible on the upper portion of your main spindle shaft. If it is not present, we highly recommend that you add this part immediately. (Part #STD 353)

BEFORE INSTALLING A NEW BALL BEARING ON A RIM DRIVE PARATROOPER MAIN SPINDLE, PUT A SAFETY RING ON THE SHAFT WITH THE TAPER CONFORMING WITH THE TAPER ON THE SHAFT. THE RING IS TO PREVENT THE HUB FROM COCKING TO ONE SIDE IF THE BEARING FAILS.

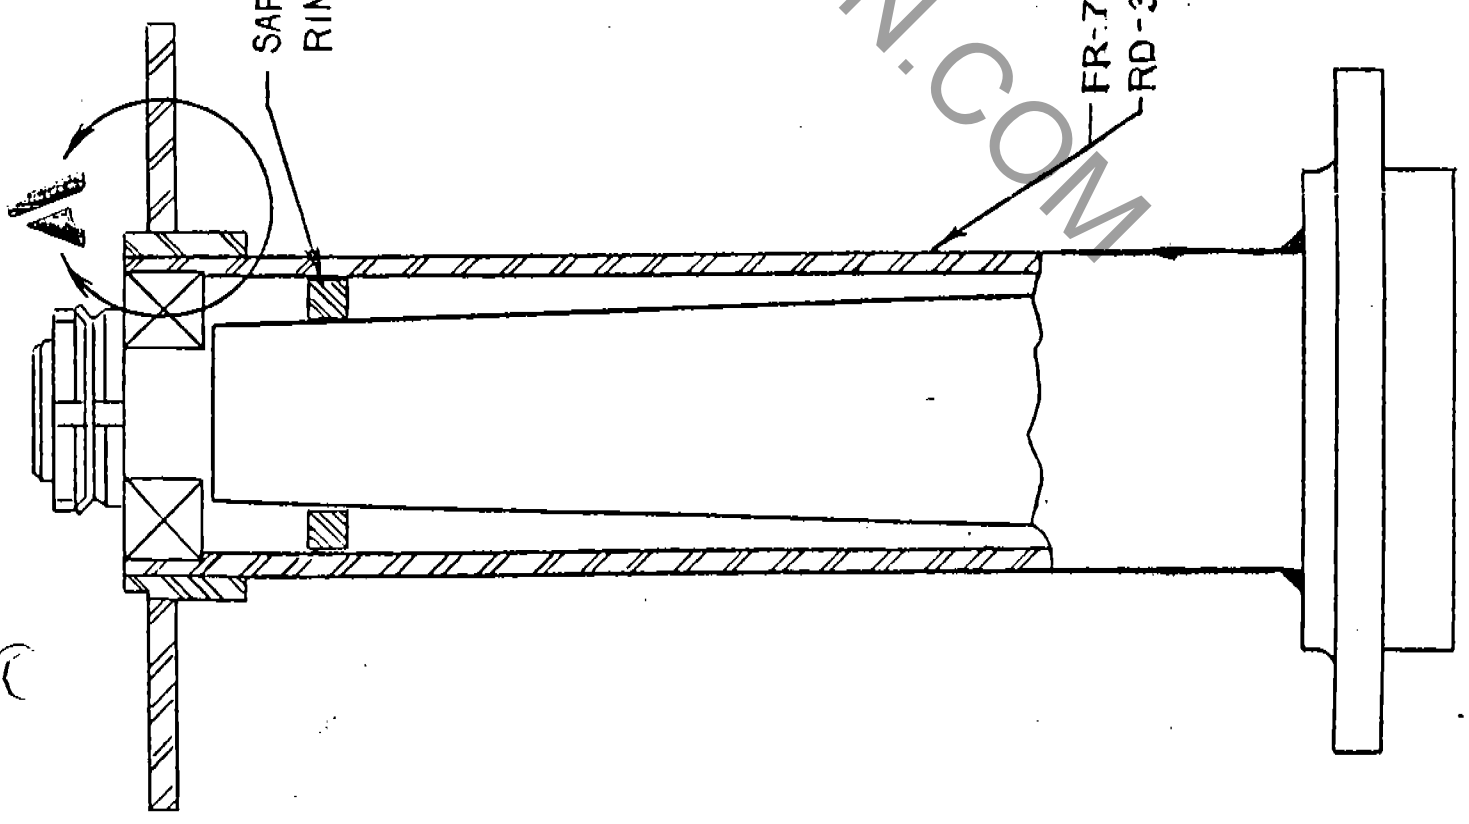
The main spindle shaft hub housing on the Round-Up and Paratrooper amusement rides that were manufactured by Frank Hrubetz Co., and Kilinski Mfg. Co. (KMC) have shown some sign of fatigue cracks in the weld areas of the hub assemblies.

AREA TO BE MAGNAFLUXED FOR CRACKS

IF CRACK IS NOTED IN THIS AREA, CENTER HUB SHOULD BE REPLACED

We at Man-Co feel that this is something that should be inspected on a more regular basis and so we are recommending that the welds shown in the attached drawing (BU-136-MC) be inspected annually. If any sign of stress or cracks are noted, then we recommend that the entire hub assembly be replaced for the safety of the ride owners and customers.

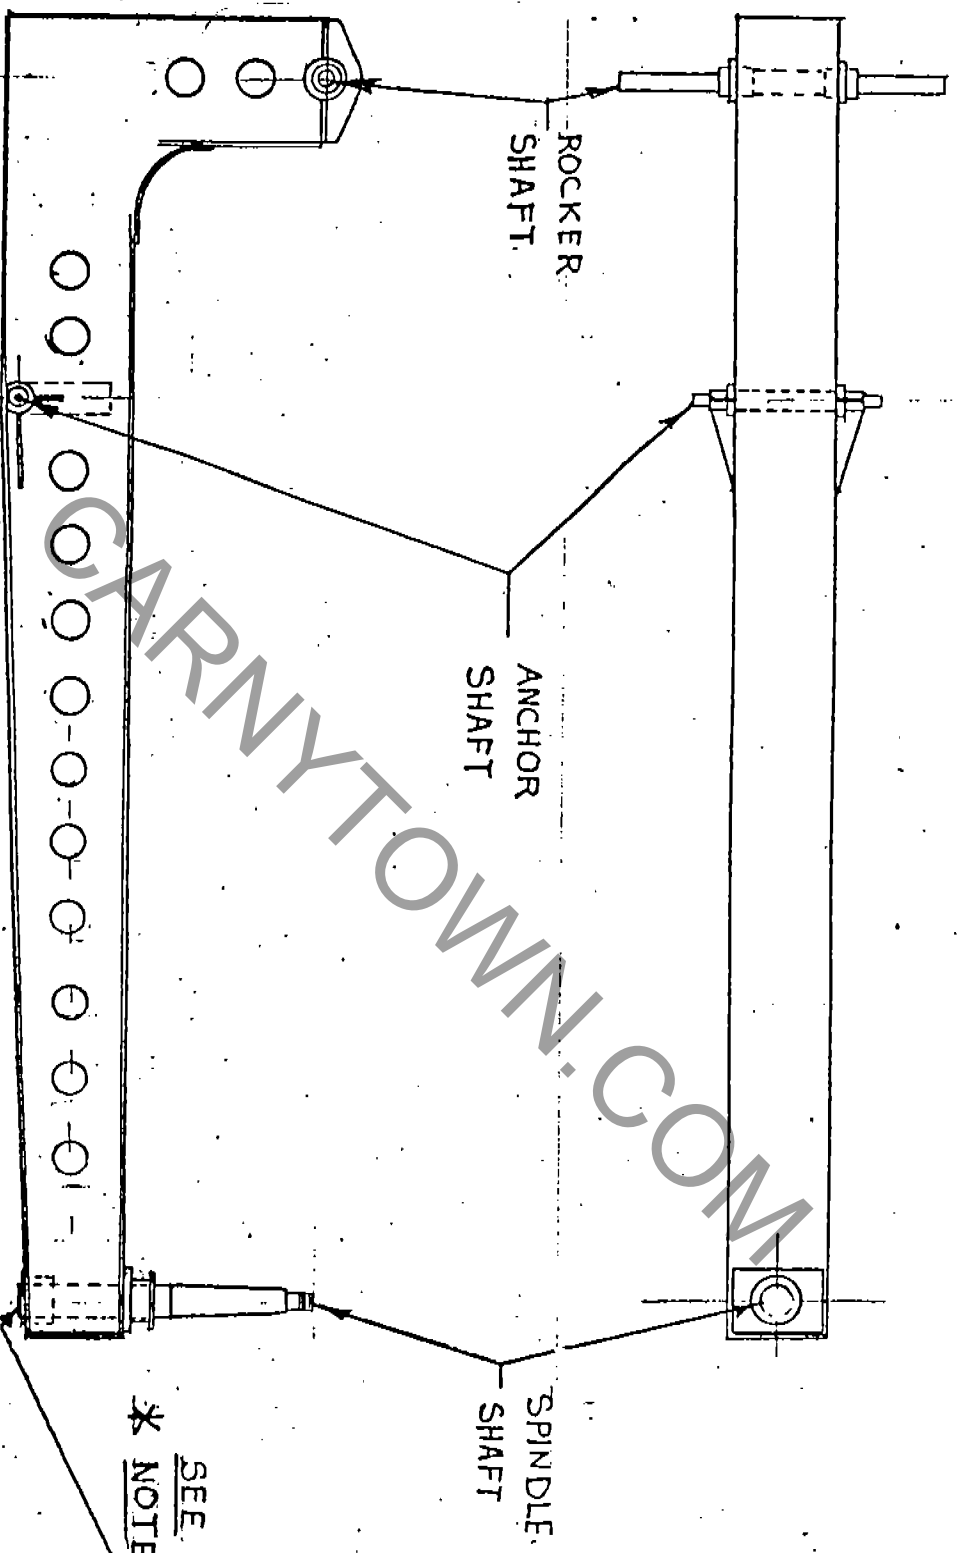
<b>MAN-CO. MFG. INC.</b>		P.O. BOX 13114 SALEM, OR 97309	
SCALE:	DATE:	DRAWN BY:	
NONE	8-31-89	SWJ	
30' FOLDING ROUND-UP		ANCHOR SHAFT	
		BU 138-A

\*NOTE: IF NO SHRINK COLLAR IS VISIBLE AT BOTTOM OF BOOM, THEN REPLACEMENT OF SPINDLE SHAFT IS NEEDED.

- 1) Inspect your ride and determine if the shafts and/or spindles are welded in directly, or if shrink collars are used. (See Drawings BU-138-A through F for information on how to determine the installation method used on your ride.)
- 2) If shrink collars are used on your ride, there is no need for replacement. Please note: All shafts and spindles still need to be tested annually according to the procedures outlined in BU-135-MC (QC-UI-1 - Rev. 3).
- 3) If the shafts and/or spindles on your ride are welded directly to the boom, then replacement is needed.

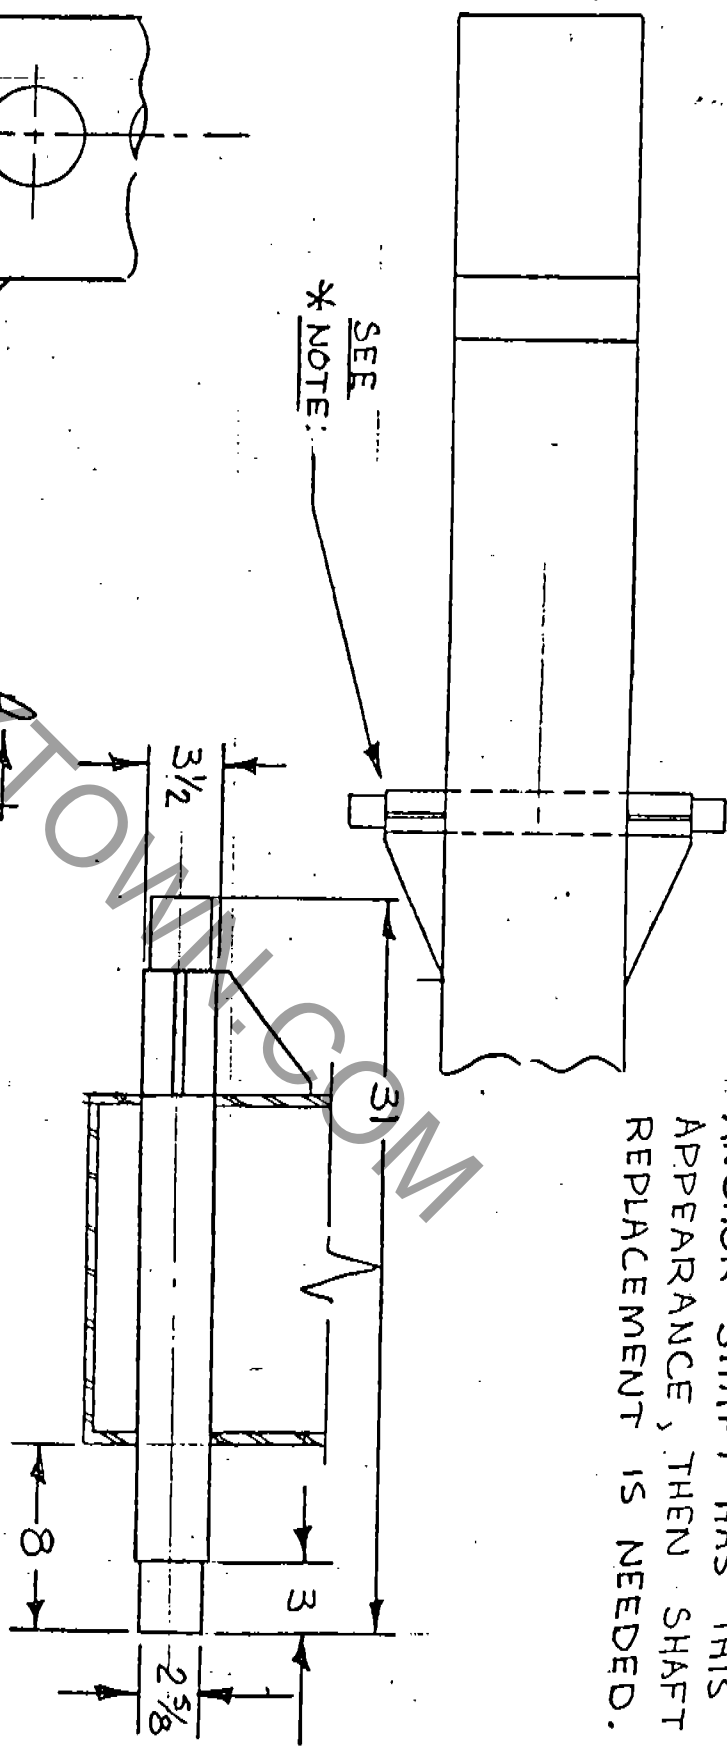
NO. BU 13B-B

\* NOTE: IF CYLINDER ANCHOR SHAFT HAS THIS APPEARANCE, THEN SHAFT REPLACEMENT IS NEEDED.

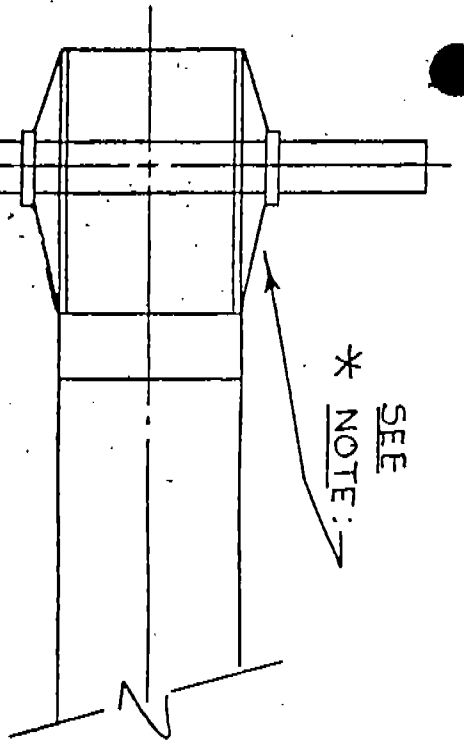
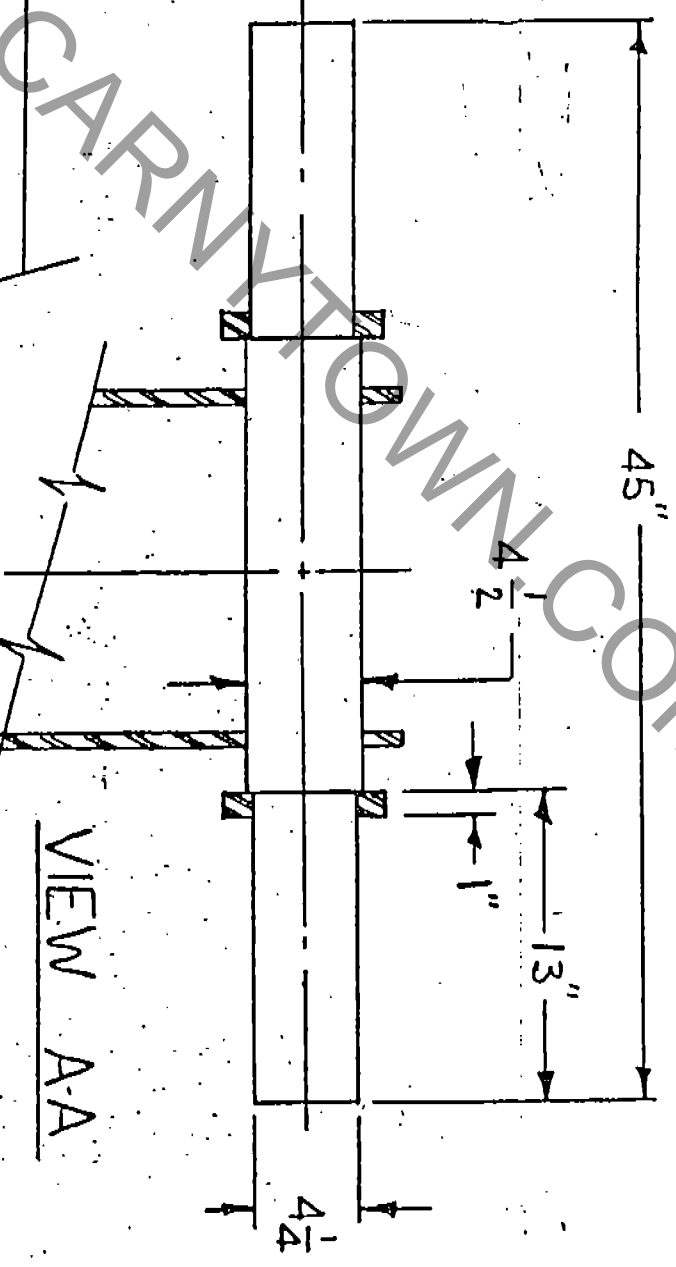
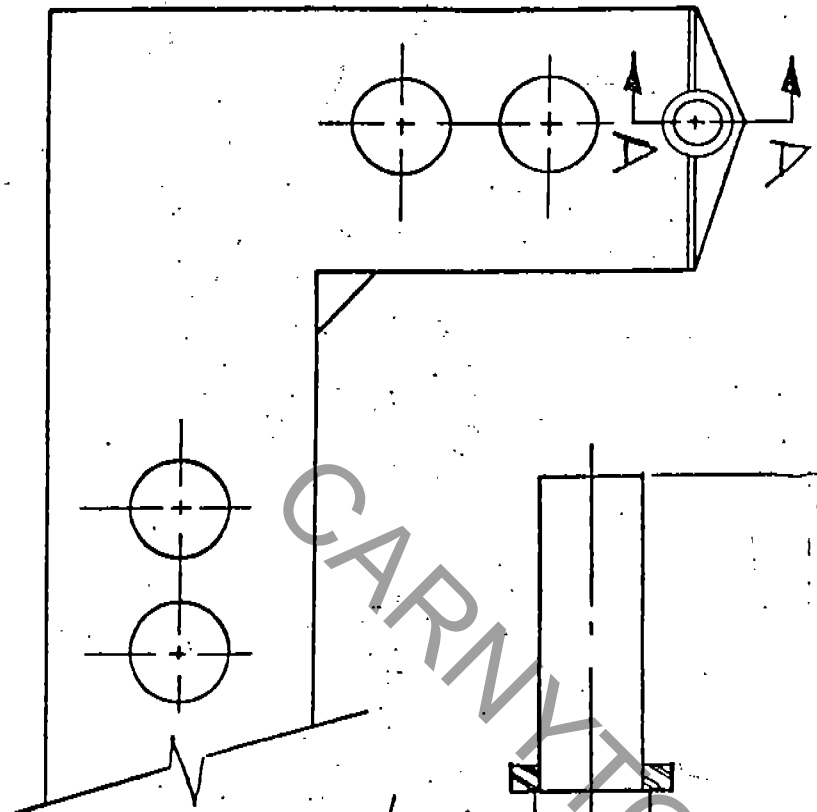
<b>MAN-CO. MFG. INC.</b> P.O. BOX 13114 SALTM, OR 97139	
MAILU Boom ROCKER SHAFT	
DATE 8-31-89	
DRAWN BY SWJ	
SCALE	
<b>NO. BU 1138-C</b>

\* NOTE: IF ROCKER  
SHAFT HAS THIS APPEARANCE  
THEN REPLACEMENT OF SHAFT  
IS NEEDED.
