MFG: REVERCHON  
NAME: HIMALAYA  
TYPE: NON-KIDDIE

# **AMUSEMENT RIDE SAFETY ALERT!**

**"HIMALAYA"**

RE: Austin, TX, Himalaya Death of 3/19/98:

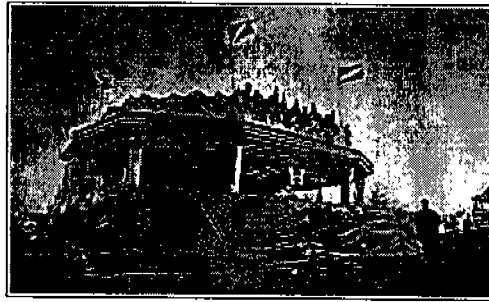
The detective said that during Lane's ride, the lap bar came loose from car No. 19 "at all three points of attachment." He said the lap bar was ejected from the car along with Lane.

Police watch the grounds near the Himalaya ride, which is fenced in and covered with plastic, at the Austin-Travis County Livestock Show & Rodeo. On Thursday, Leslie Lane, 15, was thrown from car No. 19 and died. Witnesses say the lap bar broke away. Photo by Rebecca McEntee/AA-S.
