**Tramways**

**SERVICE BULLETIN NUMBER 1997-004****ACTION REQUIRED**

**TO:** ALL OPERATORS OF HALL SKI LIFT AND VON ROLL TRAMWAYS 2/3/4-PASSENGER CHAIRLIFTS

**SUBJECT:** FAILURE OF CHAIR HANGER - RECOMMENDED CORRECTIVE ACTION

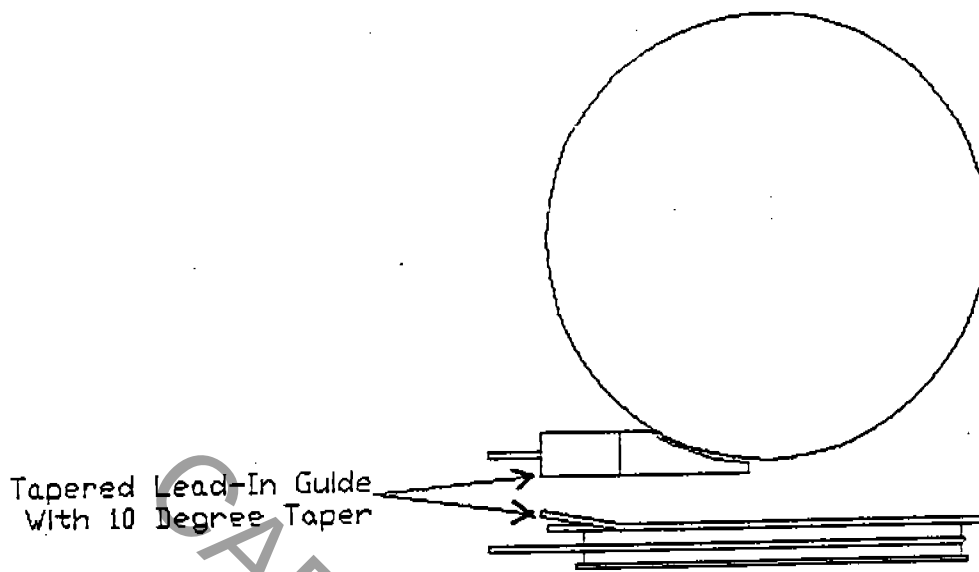
Figure (1)  
Lead-In Guide Modification

On chairlifts where there is a history or evidence of impact of the gooseneck on the bullwheel flange as the grip/gooseneck enters the bullwheel (occurs if chair is swung outward from the lift centerline as the grip/gooseneck approaches the bullwheel), provisions ~~must be~~ *shall* incorporated to provide a gentle transition onto the bullwheel flange. This ~~could include~~ *shall* an angled plate (no more than 10 degrees from the horizontal) which is level with the flange of the bullwheel. If a chair is swung outward as it approaches the bullwheel, it will contact the angled plate which pushes the gooseneck downward before it comes into contact with the bullwheel flange. Please refer to figure (1):

On chairlifts where there is a history or evidence of impact of the chair on the terminal support pedestal, guides must be placed leading into the support pedestal such that a chair approaching the terminal will be gently deflected away from the support structure. When placing guides, it is important to verify proper interface of the chair with the guide as the chair is swung both laterally and longitudinally. **On some existing chairlifts, the existing guides may not prevent chair contact with the terminal support pedestal. If this condition is observed, the guide must be re-positioned or another guide added to prevent the chair from** ~~contacting the support pedestal.~~ *shall* The guide ~~should~~ have an angle from the longitudinal axis of the lift of no more than 30 degrees and shall extend far enough in front of the terminal that a chair cannot get caught on the end of the guide as it approaches the terminal under the most severe combination of lateral and/or longitudinal swing.

Verify proper bullwheel alignment and condition of bullwheel liner in accordance with instructions IN-245 and IN-32-278.

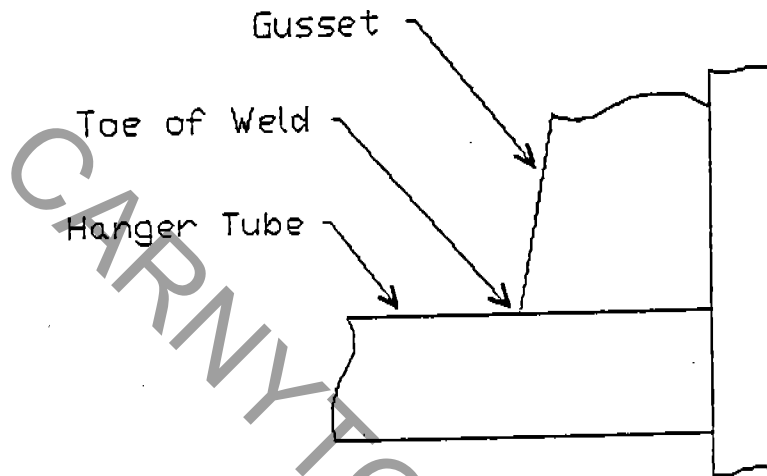
**Figure (2)**  
**Welding Position**

If any of the above non-conformities are noted, the weld shall be repaired as follows:

- The area to be welded should be cleaned of paint, corrosion and any other foreign material. *shall*
- The existing weld should be removed by grinding, beginning at the toe of the weld and extending a minimum of two inches down each side. Grinding should remove the weld and some material from the gusset, but should not extend into the hanger tube greater than a depth of 1/32 inch. **Extreme care should be taken not to remove excessive material from the hanger tube.** *shall*

- The start and stop of the weld must flow evenly into existing weld and shall be visually examined.
- Prior to welding, the hanger tube and gusset shall be pre-heated to 375 F +/- 25 F for at least four inches either side of the weld toe. The hanger tube and gusset should be well insulated for at least 12 inches on each side of the heated area to reduce the temperature differential across the area to be welded and to slow the rate of cooling. The heating can be done by either electric heating elements or by gas torches but good temperature control is important. *shall*

- Weld using 1/8 inch E7018 rod with stringer beads and less than one rod diameter weave. A DC welder shall be used with the current set at between 125 to 135 amps.
- Following the welding, the area shall be wrapped in insulation within ten seconds of completion of the weld and allowed to cool slowly.

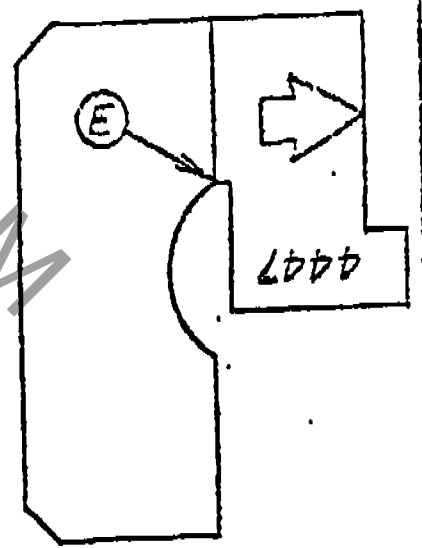
FIGURE 6

NOTE: The bullwheel liner must meet the requirements of both sides of the gauge. As an example, the liner shown in Figure #6 would meet the requirements of the test illustrated in Figure #1 and outlined in Step #1. However, it does not meet the requirements of the test illustrated in Figure #4 and outlined in Step #3 and therefore must be replaced.
