MFG: MANCO PRODUCTS, INC.  
NAME: ROUND UP - FOLD  
TYPE: NON-KIDDIE

**EMERGENCY ALERT ON THE RIDE, "ROUND-UP"  
(by Manco, Hrubutz Mfg, or Kilinski Mfg)**

In early June 1993, a Round-Up ride experienced a failure of a weld located on the shrink collar on the main center spindle (two drawings are attached for reference). This is the first known occasion for this style of shaft to fail since the manufacturer's Bulletin requiring replacement of an earlier system.

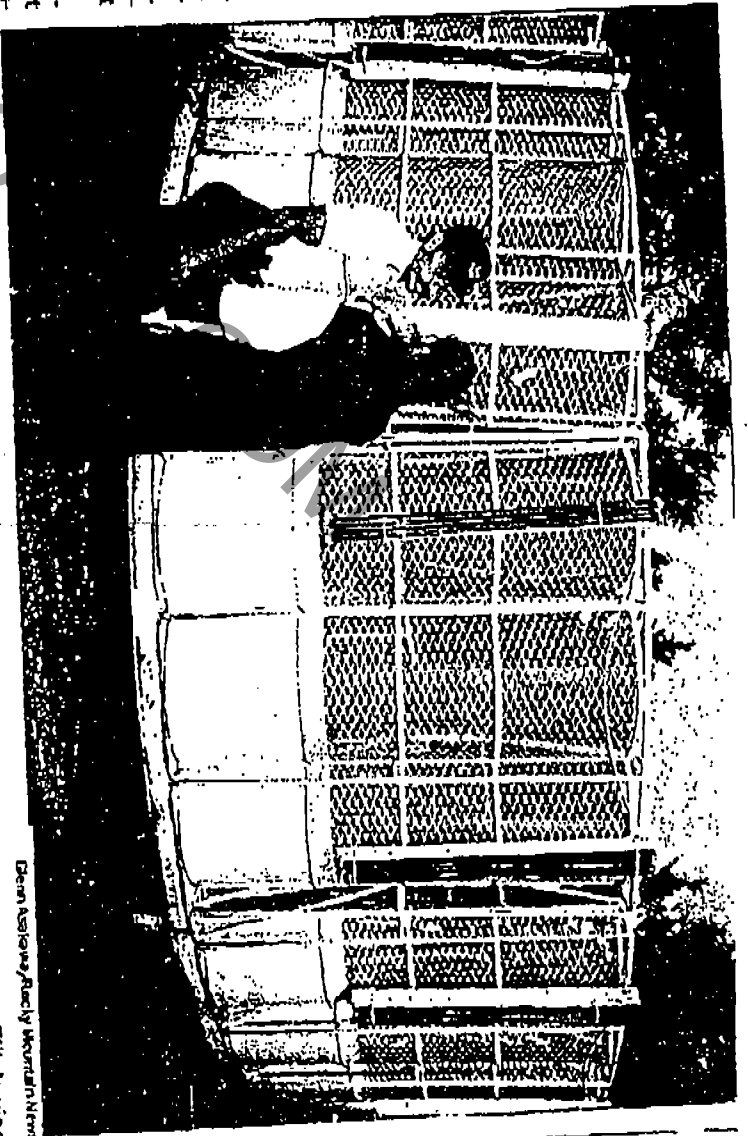
Dan Meincke, left, assistant ride foreman for Eitch Gardens, talks to Lon Lyons, Eitch vice president of administration, as he inspects the Round Up ride after it stranded riders.

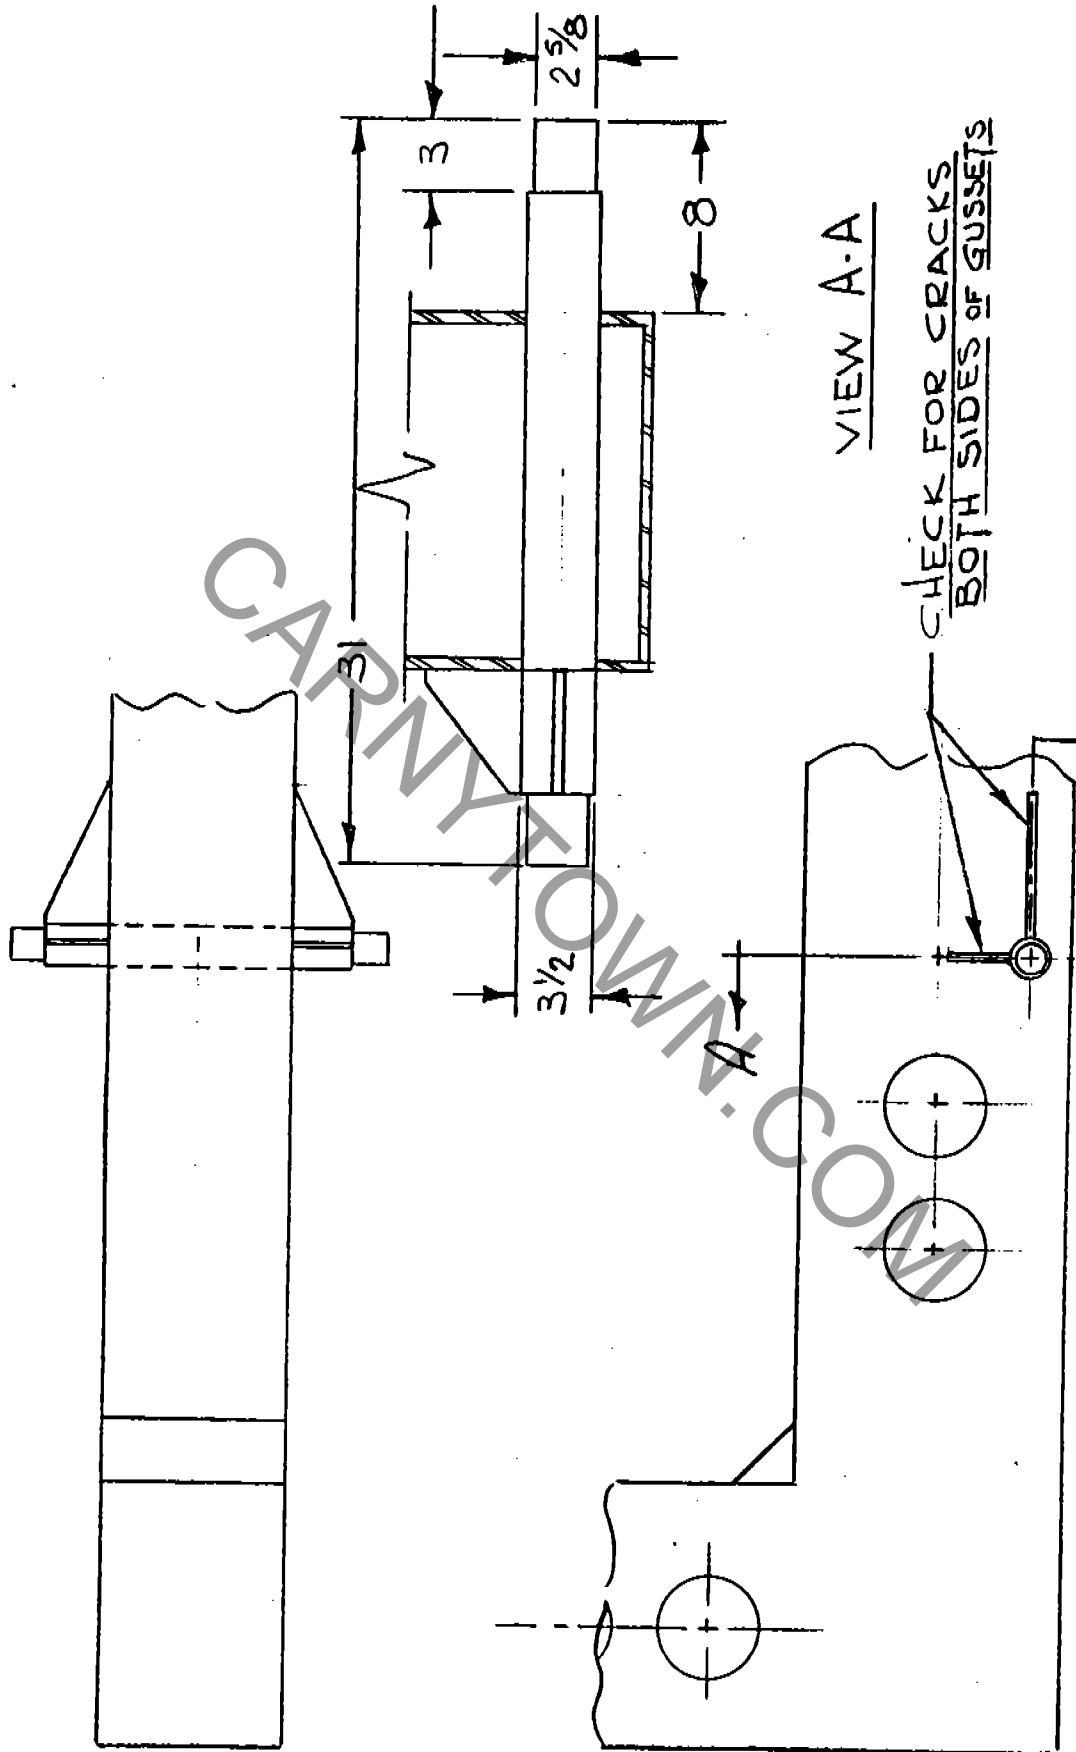
<b>MAN-CO. MFG. INC.</b>		P.O. BOX 13114 SALEM, OR 97309	
<i>CYL. ANCHOR SHAFT</i>		SHAFT DIMENSIONS PREVIOUS TO SHAFTS WITH SHRINK COLLARS	
DATE	8-14-84	NO.	SHRINK COLLARS
DRAWN BY	M.D.Z		
SCALE	---

\* NOTE: IF CYLINDER ANCHOR SHAFT HAS THIS APPEARANCE, THEN SHAFT REPLACEMENT IS NEEDED.
