**Tramways**

**SERVICE BULLETIN NUMBER 1997-004****ACTION REQUIRED**

**TO:** ALL OPERATORS OF HALL SKI LIFT AND VON ROLL TRAMWAYS 2/3/4-PASSENGER CHAIRLIFTS

**SUBJECT:** FAILURE OF CHAIR HANGER - RECOMMENDED CORRECTIVE ACTION

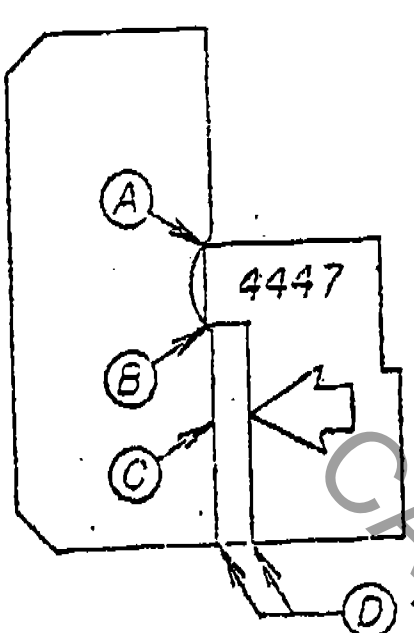
FIGURE 1

1. Place the arrow side of the gauge against the bullwheel liner as shown in Figure #1. Hold the edge of the gauge parallel to the liner as shown at "C" in Figure #1. The end of the gauge and the edge of the liner should be even as shown at "D" in Figure #1. The two corners of the gauge should make contact with the liner as shown at Points "A" and "B" of Figure #1.

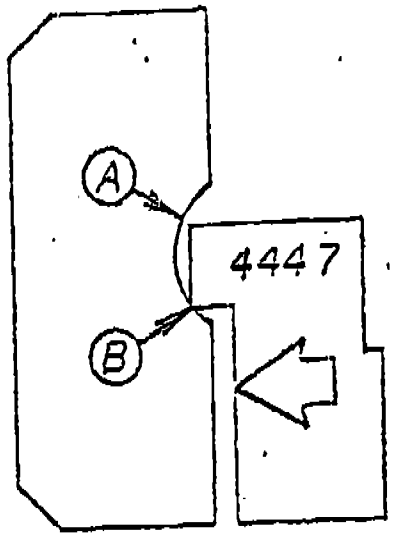
FIGURE 2

Figure #2 illustrates a bullwheel liner which is not wearing evenly in the center of the liner indicated by the gauge touching the liner at Point "B" but not at Point "A".

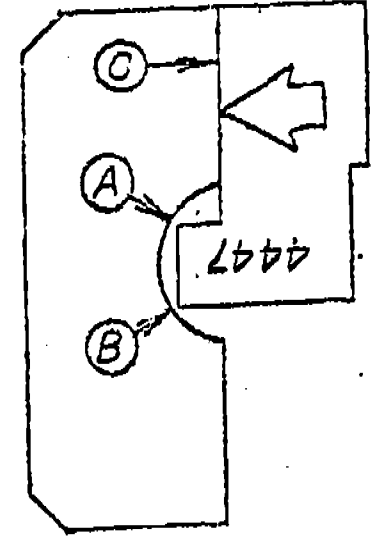
FIGURE 3

2. The gauge should be inverted as illustrated in Figure #3. If the gauge still makes contact at Point "B" but not at Point "A", the groove is wearing toward the top of the liner and is an indication that the cable may not be tracking properly on the liner. If the gauge makes contact at Point "A" but not at Point "B" at both positions of the gauge the groove is wearing toward the bottom of the liner and is also an indication the cable may not be tracking properly on the liner. Possible causes are the bullwheel may not be level and/or the cable between the bullwheel and the idler sheaves may not be level, and should be corrected to allow the cable to track properly on the bullwheel liner.

In either of the two gauge positions, if the gauge makes contact with the liner as shown at Point "C", Figure #3 and does not contact the liner at Points "A" and "B", the liner groove is worn excessively deep and must be replaced.

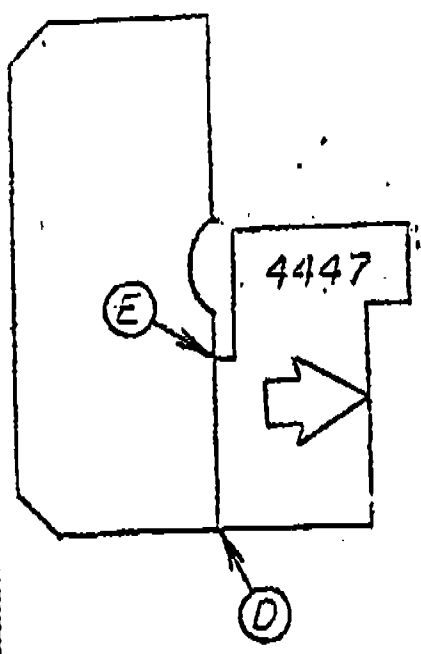
FIGURE 4

3. The gauge should now be reversed so the edge away from the arrow is against the liner as shown in Figure #4. The end of the gauge and the edge of the liner should be even as shown at "D". The edge of the groove should not reach or be past Point "E".

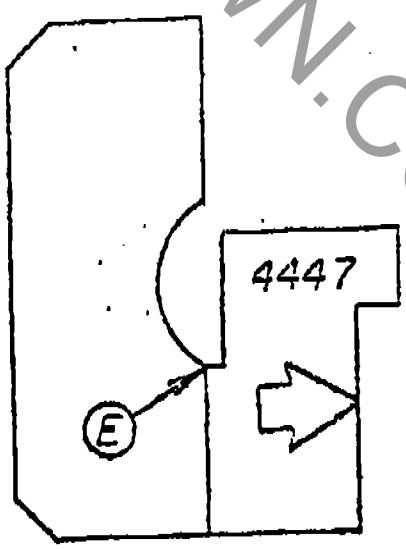
FIGURE 5

Figure #5 shows a liner worn excessively off center and has reached its maximum allowable wear as indicated at Point "E". This liner must be replaced.

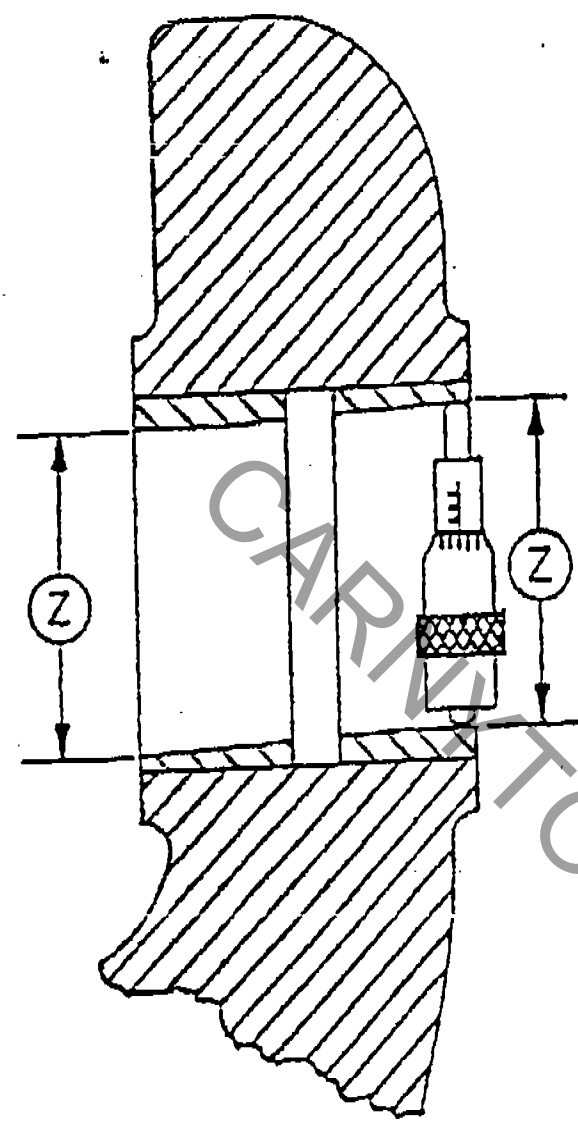
FIGURE 2.

The bushing is excessively worn and both bushings must be replaced with new bushings if the maximum wear of either bushing is equal to, or greater than, 0.010 inch. For hangers supplied with a single gooseneck bushing, take measurements at the locations shown in Figure 2, applying the formula to each end of the bushing separately.

Z-X=Wear
